Issue 24 – December 2023

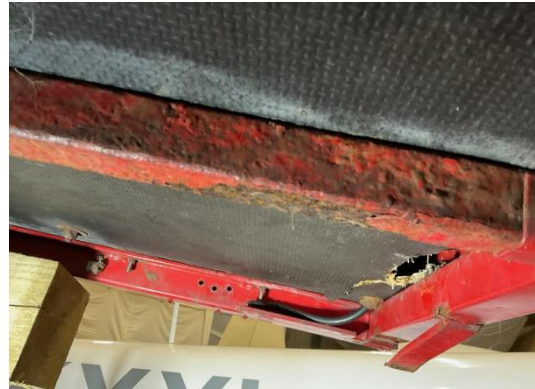
The Grob trailer – which was loaned to Staffordshire club and is now at Edgehill to see if the DG505 would fit in it - turns out to be seriously corroded and a similar one at another club did fail in use. It will need repaired - to fix the substantial cracks, and the severe rusting and corrosion to the steel box section. The picture shows just one issue of many.

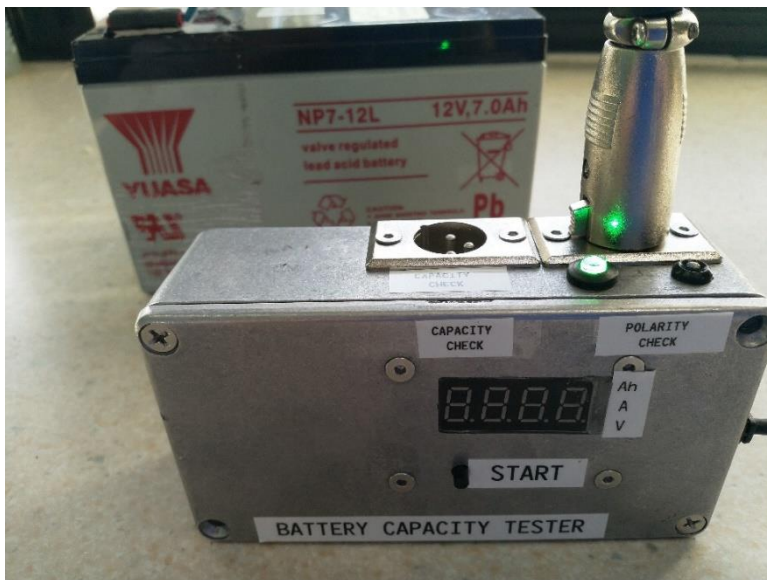
After a long cold spell, your batteries may lose some of their capacity. The club has a battery tester, so you can check the capacity of your battery, rather than discover on your next cross country flight that your battery doesn't last very long any more.

The device has two built in connectors for the standard 3 pin XLR connector widely used in the club with Pin 2 being -ve and Pin 1 being +ve. The first connector provides a Polarity Check function to confirm that the XLR connector is wired to the correct polarity and should be used before connecting the battery to the Capacity Check XLR connector. A lead with Crocodile clips is available for batteries which do not have the 3 pin XLR connector. Please use the polarity checker before connecting for a capacity test.

Green light indicates correct XLR polarity, a flashing Red light warns of reversed XLR connector polarity.

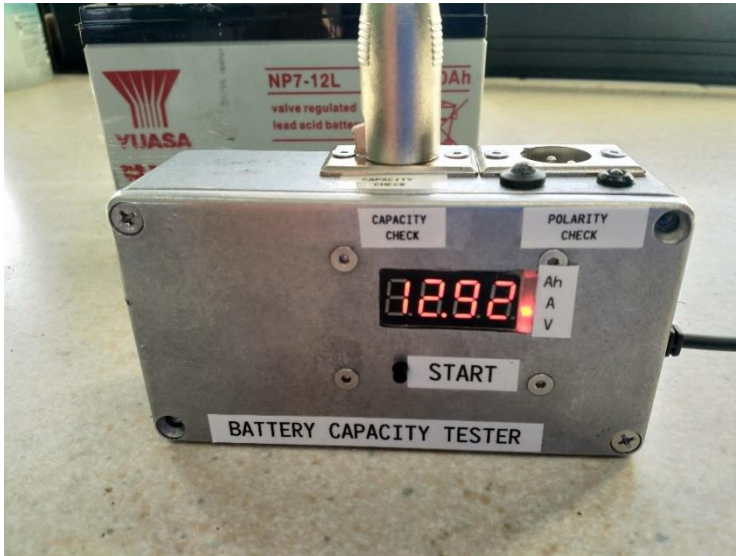
Once connected to the Capacity Check connector the display will show battery voltage.

Pressing the START button will commence a test cycle. During the cycle the display will rotate through Ampere hours (Ah), Amps (A) and Volts (V) values. When the Capacity Check is complete it will display only the Ah capacity of the battery.

Note that a Capacity Check on a full capacity 7Ah battery will take around 17 hours and for the larger 10Ah battery around 24 hours.
